Shenzhen Shekou Container Terminal (SCT) 深圳蛇口集装箱码头

Aviation Fuel Supply Company Sha Chau Plant 香港航煤供应营运有限公司

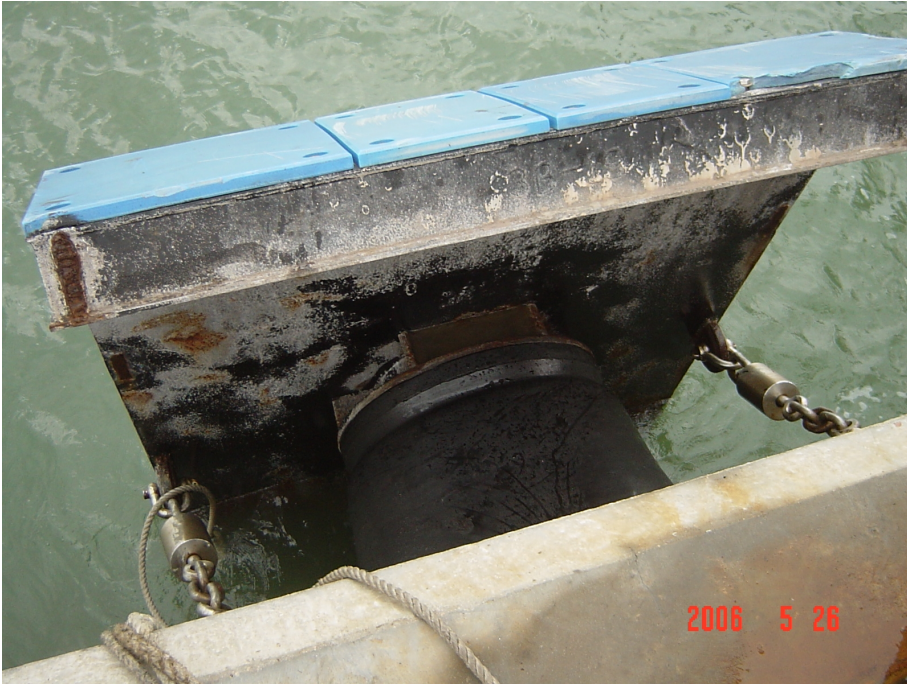
A 2 years old China made fender, paint got thinner and rusted!

一个中国制护舷于使用两年后防冲板油漆出现稀薄及锈蚀情况!

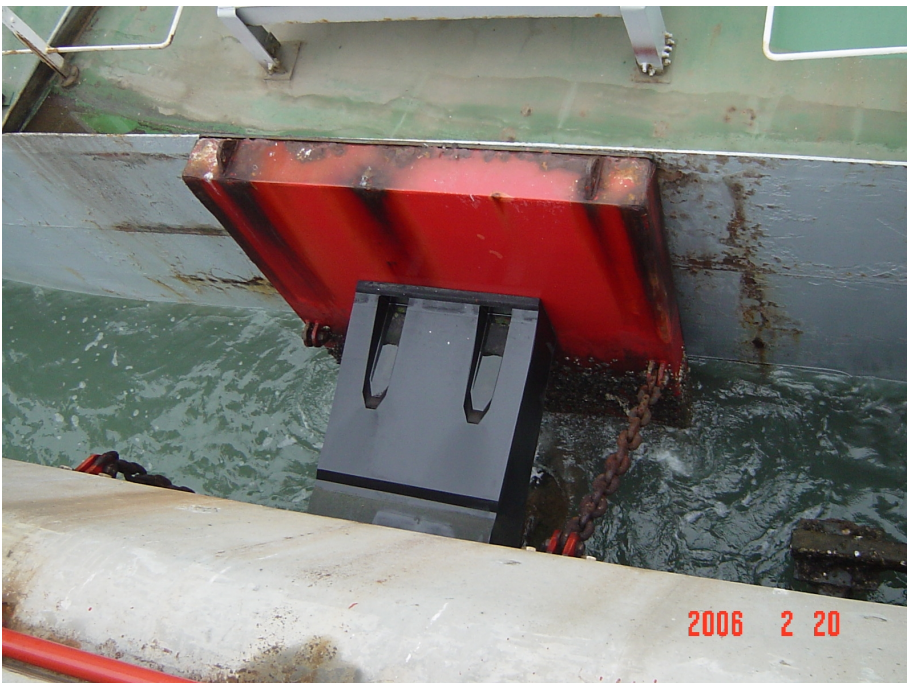
Under the AFSC regular "Fender Renewal Plan", an 8 years old Trellex fender, condition of paint was still O.K.

一个 Trellex 厂制 MV1250 护舷于使用八年后防冲板油漆情况。

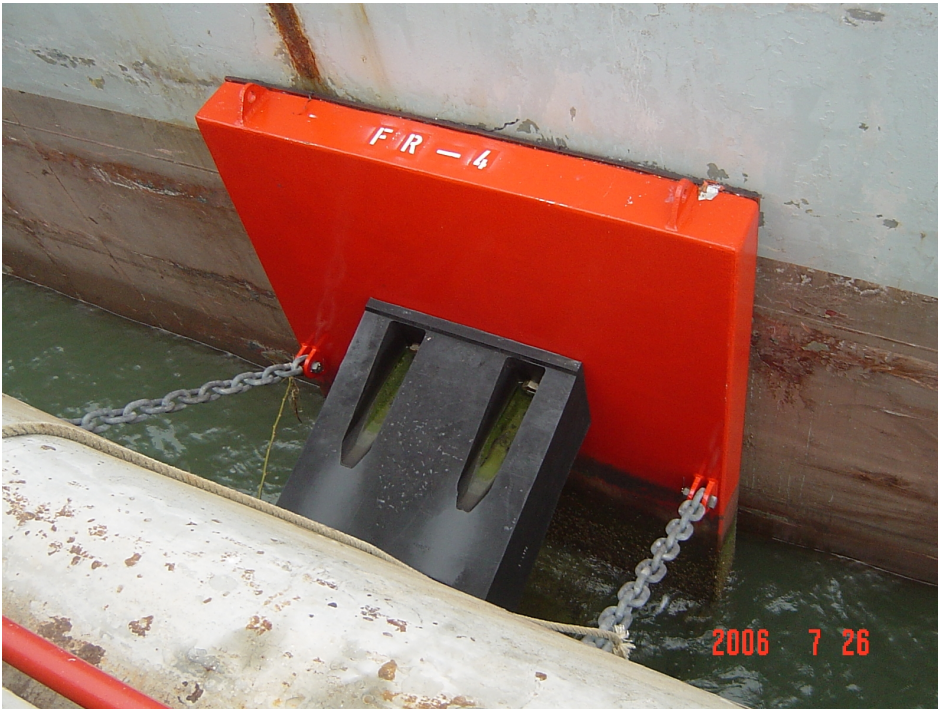
Aviation Fuel Supply Company Sha Chau Plant 香港航煤供应营运有限公司

In 2006, 8 nos. of Trellex fender Panel was sandblasted, re-painted and re-installed

在香港航煤供应营运有限公司的”定期更换护舷计划”下，总共八个 Trellex 厂制之防冲板经喷沙、再喷油漆后装回再用。(资料提供：香港航煤供应营运有限公司李国基先生)
